St Mary's Church, Alne Archaeology

SAINT MARY THE VIRGIN, ALNE.

UPDATED REPORT ON AN ARCHAEOLOGICAL INVESTIGATION

OSA REPORT No: OSA11WB25

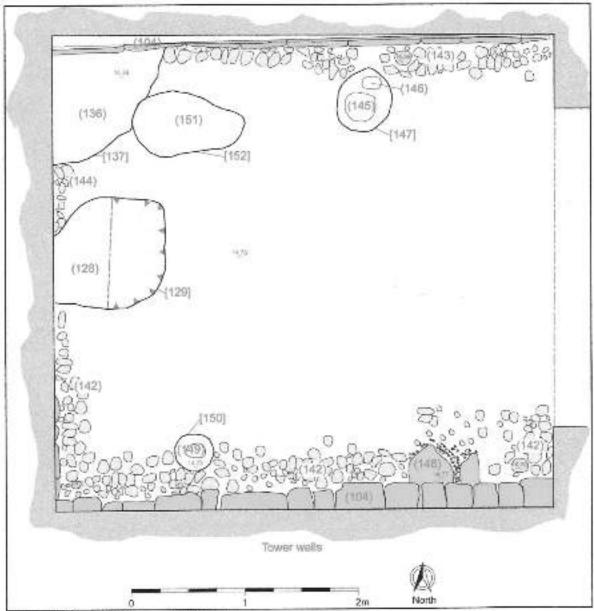
Figure 3. The earliest features in the tower

The natural sub-soils were not defined due to the nature of the level of impact within the west tower, but early features were identified during the work carried out in the tower (Plate 1). The earliest features that were extant within the area were what appeared to be original foundation structures (Figures 2 and 3). Three lengths of cobbling (142), (143) and (144). were identified as a possible foundation of the 12th century tower (Plate 2). The features proved to be slightly off alignment with the later tower construction and also wider than these footings (by approximately 0.40m in the south), demonstrating that they belonged to an carlier phase of building. A further large piece of masonry, (117=148), was noted to be bonded to the length of cobbles (142) on the southern extent. (117=148) measured 0.67 x 0.40 x 0.20m and was constructed of sandstone. The piece appeared to have been left in situ and keyed into the later tower modification (104). Although no dating evidence was retrieved from these structures, they underlay the large levelling deposit (138) which was associated with the later re-modelling of the tower. (138) was a mid reddish brown clay deposit containing occasional small stones (average size 0.03 x 0.02 x 0.01m) and charcoal flecks. The layer covered the entire area of the floor of the tower and sealed the earlier cobble structures. It appears that (138) had been used as a levelling deposit during later tower reflooring, no finds were retrieved from (138) and its depth ran to below 0.30m. The full depth of the deposit was not realised as the level of impact ceased any further need for excavation.

The earliest feature recorded was the foundation of the original, presumably 12th century, church tower. This foundation was constructed using unbonded cobbles and was built on a slightly different alignment to the current tower. The interior of the original tower may have also been slightly smaller than the subsequent rebuild, or the foundations were substantially wider than the above ground walls.

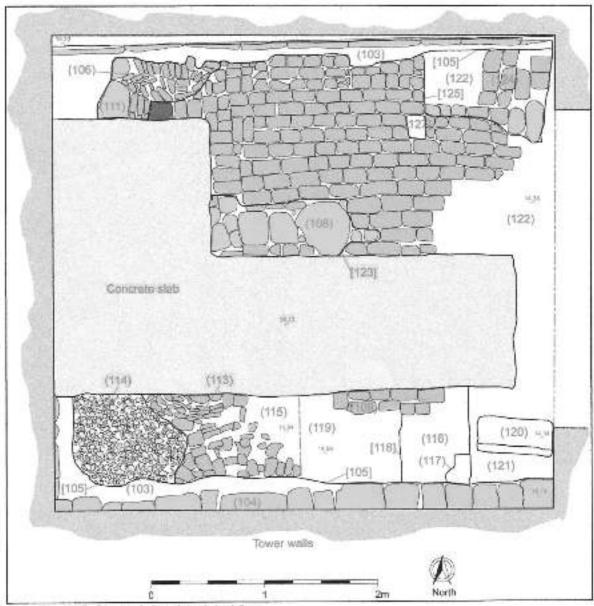
Figure 5. Early flooring below the original floor

levelling deposit for later floor levels and measured 0.10m deep. This deposit sealed the large deposit (138) and the cobbles (143) to the north. Immediately above (134) was the bedding deposit (112), which was a thin (0.03m) light brown silty sand. This lay directly as a bedding deposit for the red brick floor surface (107).

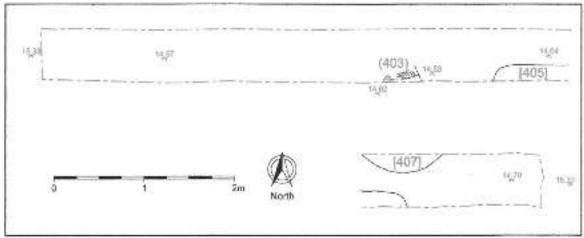
Figure 6. Plan of trench 4

Trench 4 measured 10m long by 0.90m wide and was levelled off at a depth of about 1.00m along the base. The trench was intended to house a covered soak away. Seven contexts were identified along the length of trench beginning with (401) which was soft mid greyish brown silty clay with frequent roots. It was the topsoil overlying the graveyard and contained several disarticulated human remains. It was 0.30m deep. (402) was identified as the subsoil and was not fully excavated so the full depth was not realised. It was mid reddish brown silty clay. Two features were identified as being cut into this layer, namely [405] and [407] along with an inhumation (403). (403) was the inhumation of an infant or child (Plate 6). It was a

supine east to west burial with the head slightly tilted to the south. Although the condition of the bone was of a good to medium state the body was heavily truncated to the east with the pelvic region and lower arm missing. These were probably cut through by the western extent of the grave [405], but this was difficult to discern due to the ground conditions. The grave cut of the burial for (403) was equally difficult to identify and was not recorded. [405] was identified as a possible grave cut that measured approximately 1.80m by 0.20m+ along an east to west axis. It was unexcavated as it was only identified at the level of impact and also ran into the southern edge of excavation. (404) was the single fill of [405] and was a firm dark brown sitty clay which contained fragmentary human remains which were not excavated due to the level of impact. The full length of [405] was not fully realised as it was very difficult to see the cut in the ground conditions. A similar problem was encountered with [407], a further grave cut. This was measured as 1.10m long and 0.18m wide. This feature ran into northern edge of excavation and was not fully recorded. The single fill, (406), was firm dark brown silty clay with fragmentary skeletal remains. This feature was not excavated as it was identified only on the level of impact.

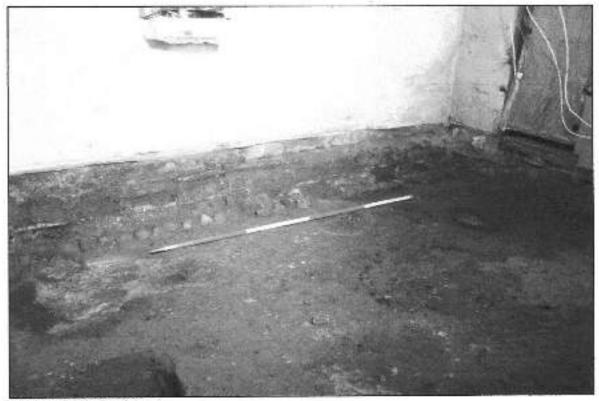
Plate 2. Cobble foundations

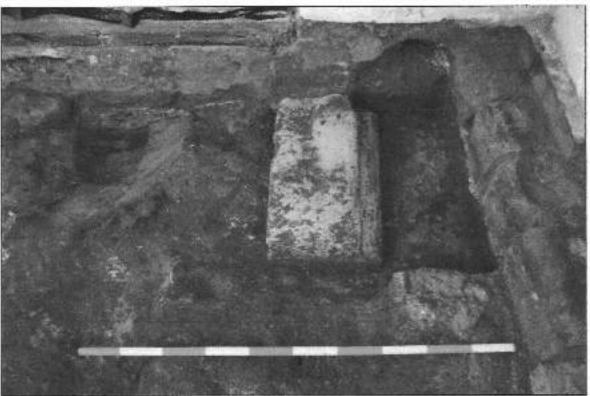
In the south eastern corner of the tower several contexts were identified, (122) was a dark brown sandy silt layer similar to (121) but more compact. Within the layer (121) a large architectural stone was recorded as (120). It measured 0.56m x 0.31 x 0.12m and was not in situ (Plate 3). These deposits were overlain by the possible lime and mortar floor surface

Plate 3. Architectural stone in situ

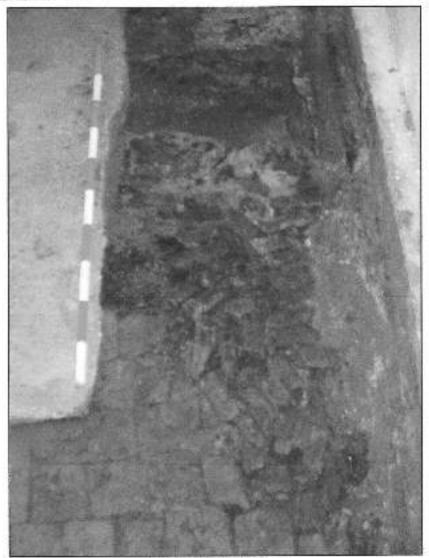
charcoal. The floor surface (107) was also disturbed in the north west corner and filled with the raised brick surface (106) (Plate 4). These bricks were laid in a haphazard manner for an unknown purpose. This area of disturbance was butted by the fill (110) and sandstone blocks (111). (110) was a dark greyish black coal and was possibly associated with burning. The stratigraphic sequence of (106), (110) and (111) was not possible to ascertain with any clarity.

Plate 4. Disturbance (106)

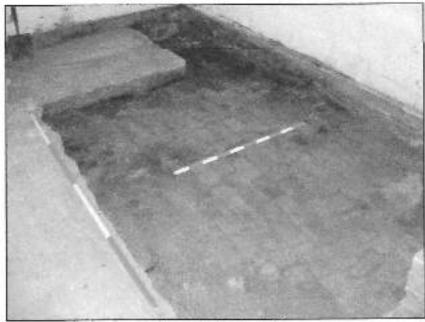
The large floor surface (107) was made up of bricks measuring 0.24 x 0.11 x 0.04m on average (Plate 5 and Figure 4), and this surface was further truncated by three cuts [123], [125] and [127]. [123] appeared to be a phase of repair and contained the large architectural stone [108], which measured 0.40 x 0.40m. The bricks making up this surface were identified as possibly 18th century in date. [125] was a similar phase of repair or disturbance and contained the mid reddish brown sandy silt fill (124). This fill contained occasional red bricks and cobblestones and was 1.15m long, 0.60m wide and 0.10m deep. The cut [127] was a steep sided and deep post hole that appeared to form part of the floor (107) but was of unknown purpose. The fill (126) was dark brown sandy silt with occasional CBM and

Plate 5. Brick floor 107

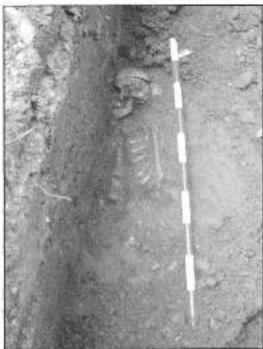
Plate 6. Skeleton 403

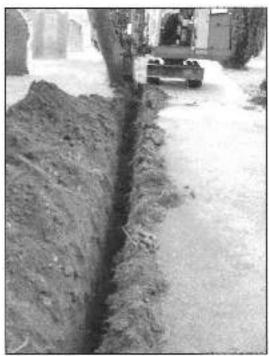
There was a 60m long drainage cut for a water pipe that ran almost the entire length of the graveyard from east to west with a right angled turn close to trenches 3 and 4 (Plate 7). It was cut to a width of 0.30m and a depth of 0.60m along its length. (500) was a 0.30m deep deposit of dark brownish grey loamy soil including turf. (500) was the graveyard modern topsoil and contained several disarticulated human remains. (501) was dark brown loamy soil, very similar to (500) but with no turf and was subsoil, this layer also contained a large amount of disarticulated human remains. This was only excavated to a depth of 0.30m so a full depth was not realised. (502) was a mix of modern brick and concrete footing for grave slabs laid at the entrance of the church. It had a maximum depth of 0.30m and overlay (501).

Plate 7. Excavaling trench 5
