CONDITION

GERMAN 7.5 CM.
STURMGESCHÜTZ
(STU.G. 7.5 CM. K.)

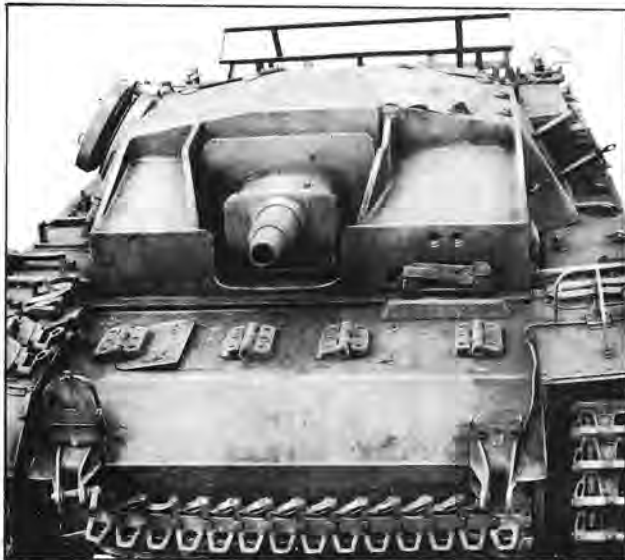
FIG. 4

The driver is provided with the normal elongated laminated glass block and shutter.

In addition, he uses an episcopes formed by two KFF. 2" periscopic telescopes. The carrier for these is deficient, but it must differ from the normal type since there is no room on the right to slide it away when not in use. Presumably the carrier is pivoted and swings away to one side.

On his left only is a fixed slit backed by a 50 mm. laminated glass block.

Access to the driver's compartment is normally through the gunner's hatch, but he can also escape through the steering brake inspection flaps in the glacis plate. Each of these flaps comprises two doors of equal size, hinged to the sides.
