The Old Oak of Ross

an illustrated story of a tree's survival and decline

Jerry Ross F.Arbor.A

November 2024

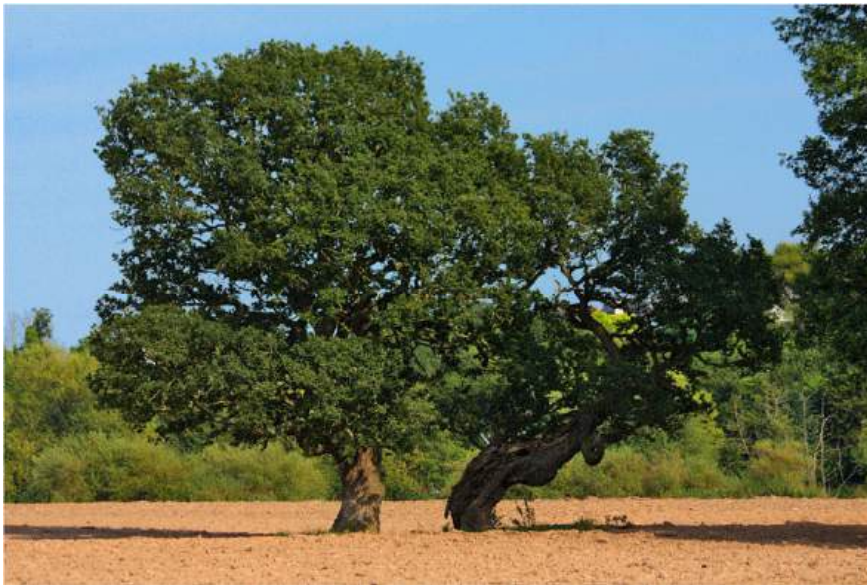
1)

Despite its fragmented form it retained its vitality with both sections clothed in foliage that created a more or less full canopy, as can be seen from the photograph below, from 2012.

Photo Sept 2012 [© Dave Pearson]

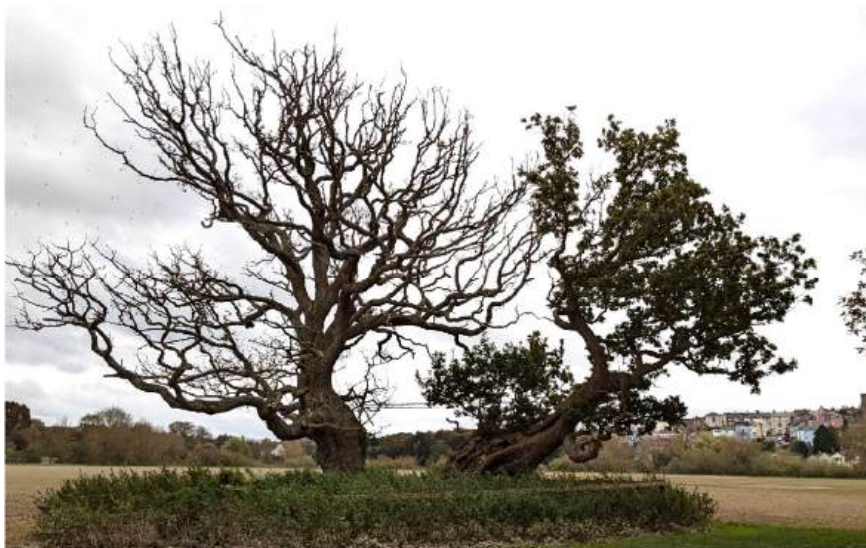
2)

Sadly, in the few years since then it has shown a very marked deterioration and October 2024 it had declined so far that the more upright, northern section of the tree has lost all its leaves, giving every appearance of having died.

Photo: JPR 2024

Close inspection showed some live buds remaining and it is possible that these *might* give rise to some scattered new growth next spring. However, it's clear that the tree, or at least this northern part of it, is in serious trouble and that its long life may be drawing to an end.

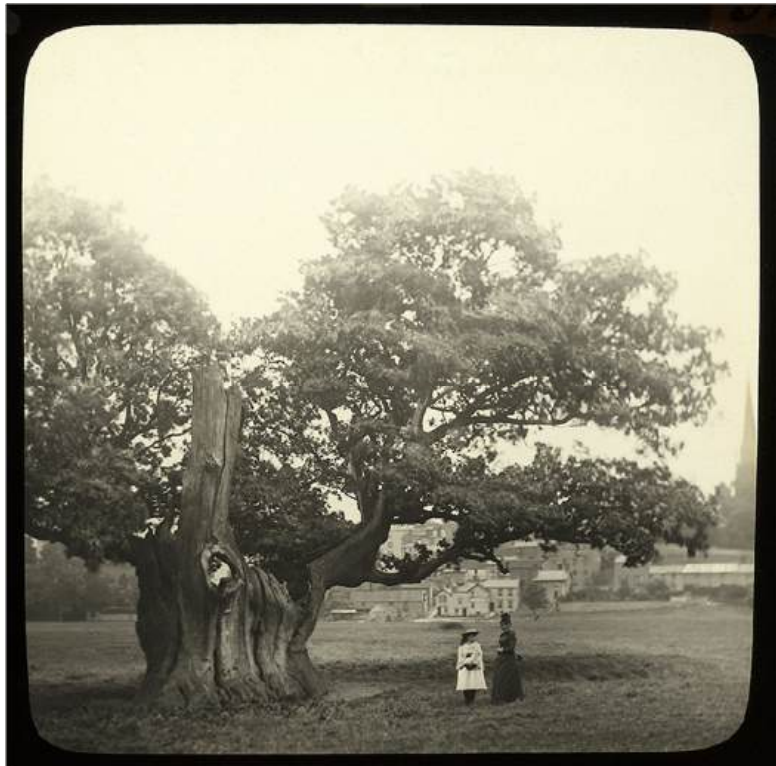
5)

Copy of a lantern slide, kindly provided by Archie Miles. believed to date from c. 1880.

The trunk, although quite hollow, remains more or less intact on this side but dead, with live growth on the boughs on either side.

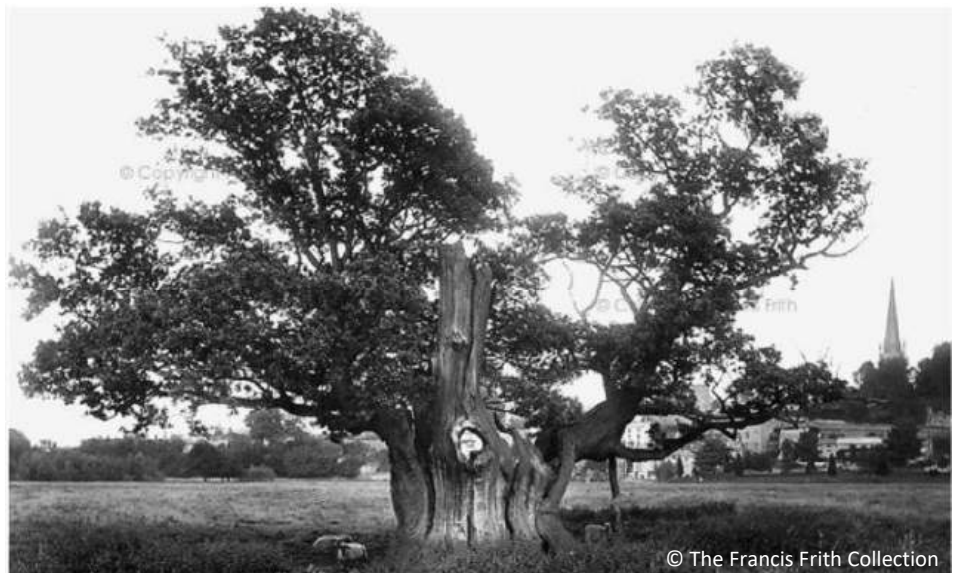
6)

Photo dated 1914. Note the wooden prop under the leaning, northerly bough which is not visible in the 1880 photograph.. (Note also that there are some indications that this image may be earlier than the given date of 1914: compare with photo 8, taken 1907.)

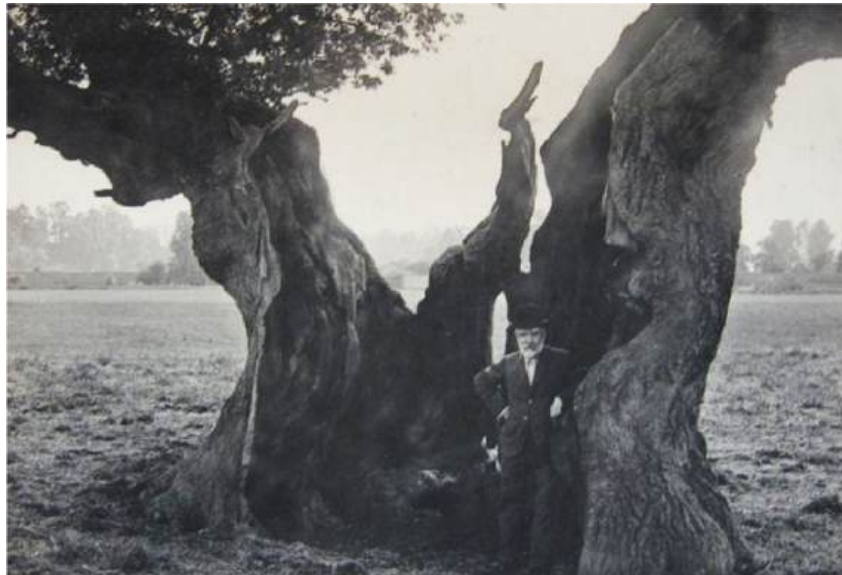
8) 1907 Photograph from The Woolhope Club (ref (HAN 82/1) The accompanying commentary states "On the other side of the river in the middle of the horseshoe bend could be seen two parts of a single tree. This is the 'Domesday Oak'. In 1896 the circumference was 45ft and only calculated to date from the 15th century. When photographed in 1907 it was said to be considered to be 1100 years old" (Authority unknown)

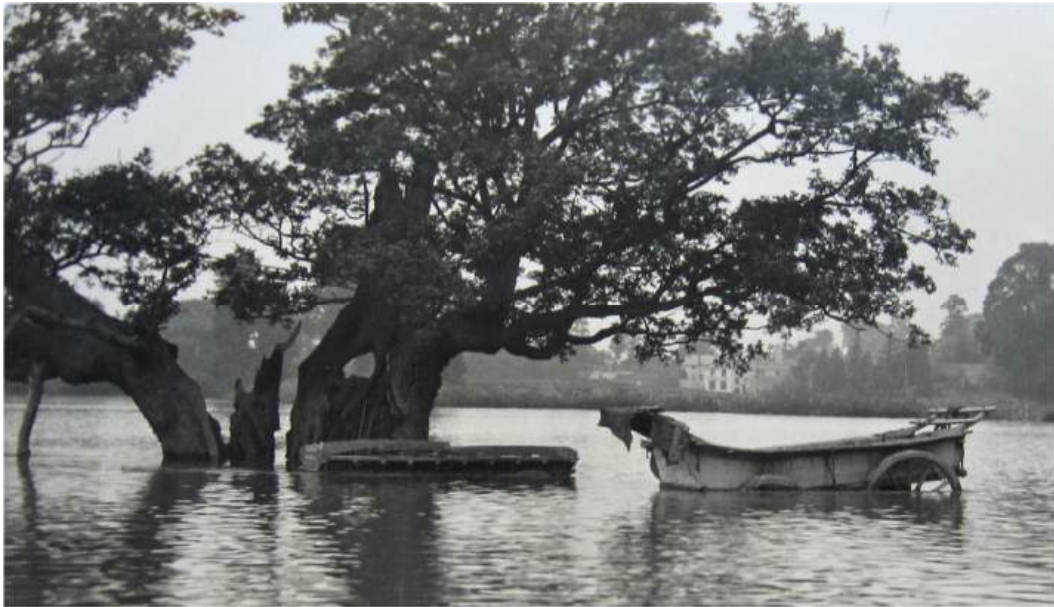
9) The tree during a flood event in August 1912 Photograph by Mr. A.G.Beeston (1912)
 Note the prop supporting the leaning bough on left. From <http://www.ross-on-wye.com>

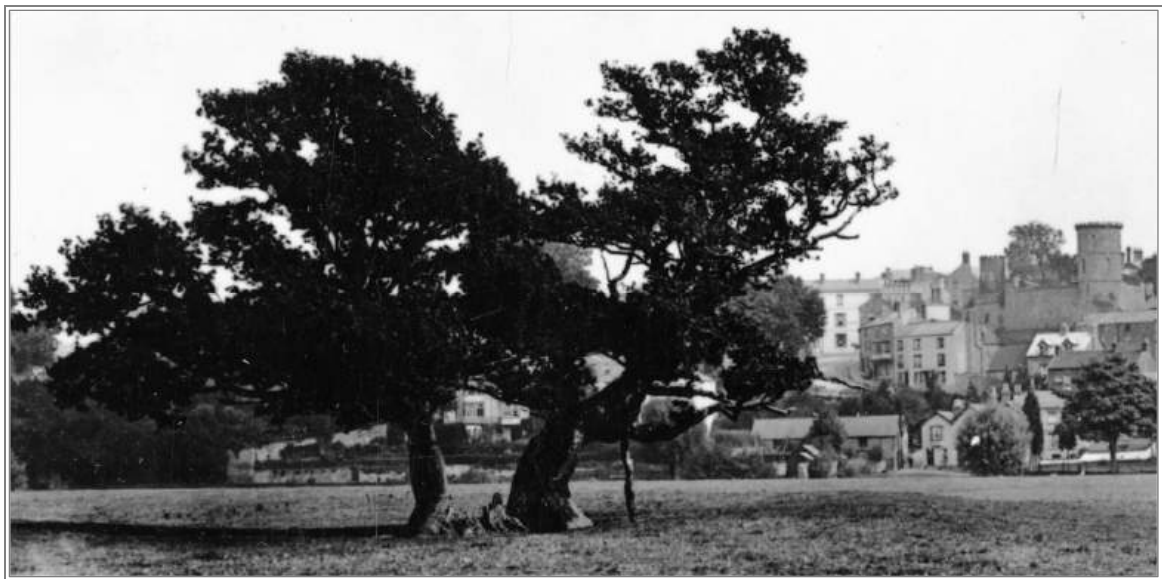
The last remaining section of outer shell eventually fell away some time between 1912 and 1929, when the photograph below was taken. This shows traces of wood still present at ground level.

10) ‘Ross on Wye town from the meadows 1929’ Photograph by Alfred Watkins
 (From the Alfred Watkins Collection held by Herefordshire Libraries)

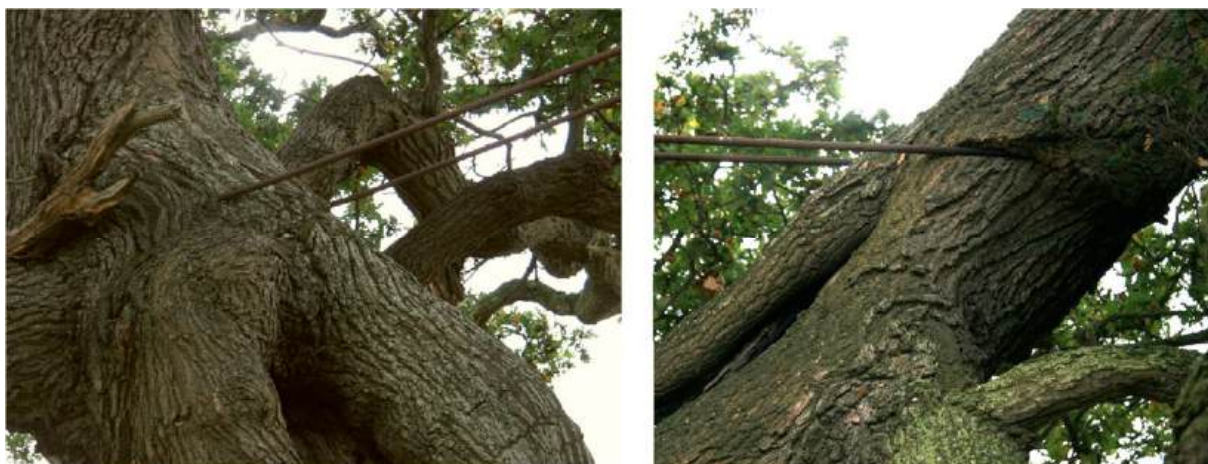
This consisted of a pair of iron rods spanning the gap between the two sections that were attached to iron brackets made to fit around the rear of each part of the tree. This system continues to support the two parts, both of which have continued to grow to the point where the iron-work has been partly, or in the case of the northerly section (on the left in the images below) *completely* overgrown by new wood.

11 Iron bracing rods on the northern stem (left) and on the southern section (right) (Photos Brian Jones 2012)

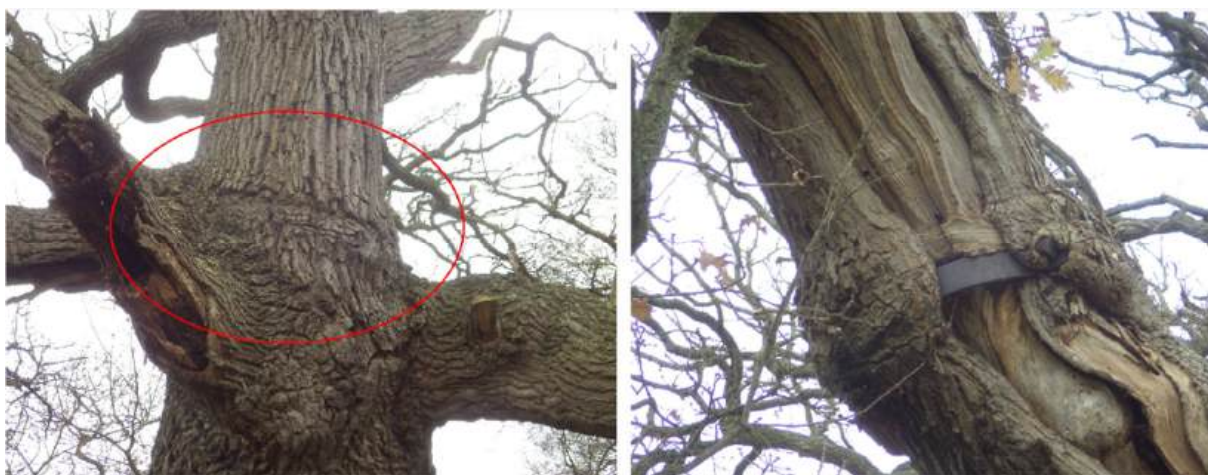
12 Left: Rear of northern stem: the bracket entirely hidden by overgrown wood (ringed)
 Right: Bracket partly exposed at the rear of the leaning, southerly section. (Photos JPR 2020)

Further evidence of the vitality of this part of the tree is provided by the way that it has grown so much in circumference as to have completely overgrown the two iron bracing-rods and to bury the substantial iron components of the bracing system so that the presence of the collar is only being betrayed by some distortion of the bark (photo 12).

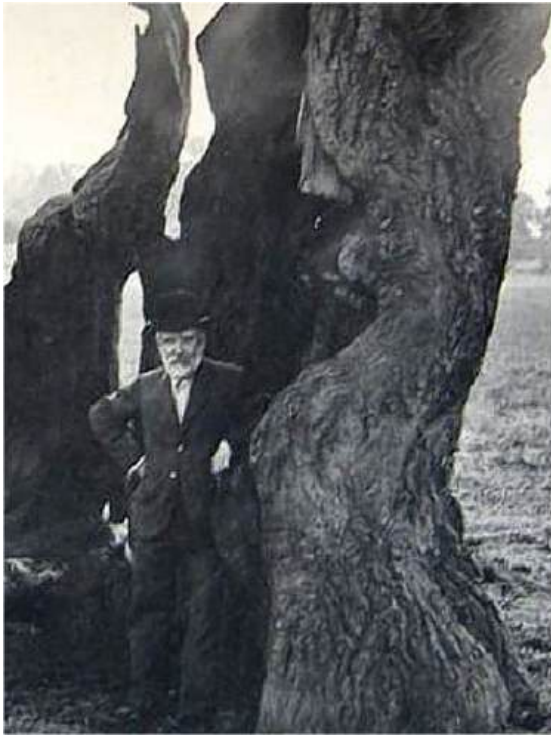
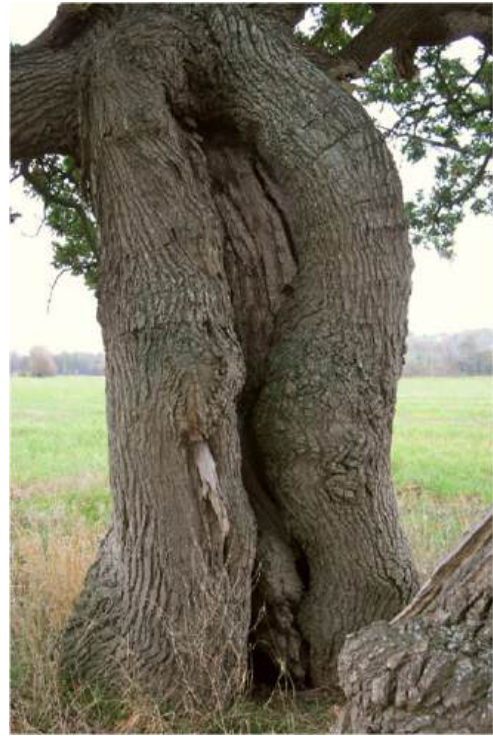
This contrasts with the more upright northern part which by 2012 has developed a full, dense canopy. Furthermore it has been able to achieve some fairly remarkable growth of its stem. This can be appreciated by comparing the two photographs reproduced on the following page. On the left is an extract from photo 8, dated 1907 showing the gentleman in the bowler hat leaning against the edge of the northern part of the tree. Behind him is a wide open hollow within which he could easily stand. Contrast this with the photograph on the right and showing that same the northern part of the tree in 2011. By that time, massive rolls of 'wound wood' had been laid down, to such an extent that the hollow has largely been occluded, leaving an opening hardly wide enough for a child to squeeze through, let alone a full-grown man.

13 Left: detail from photo 8, view taken from W to E. Right: the same northern stem in 2011 (viewed from S to N) showing the hollow largely occluded by wound-wood (2011 photo by Brian Jones)

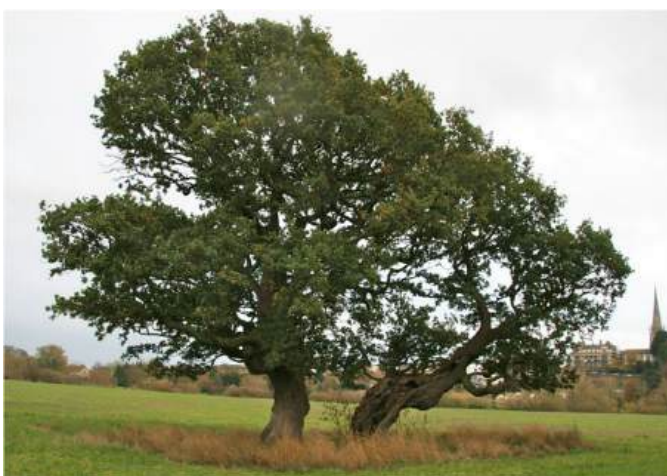
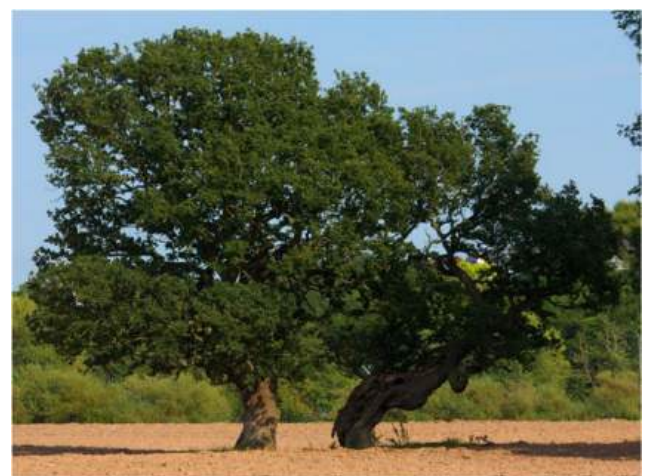
This process is clearly visible in the series of photographs, starting in November 2011. At that time the tree had a relatively full crown which, by September the following year had, if anything, become denser and more full.

14 November 2011 Photo by Brian Jones Sept 2012 (Photo 1 [copy] © Dave Pearson)

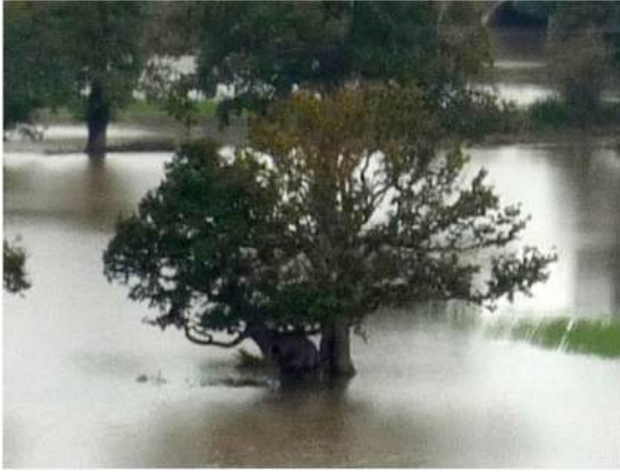
Images from 2019 to 2014 are provided overleaf and show a marked, progressive deterioration over the period until in October of 2024 the northern (left-hand) section of the tree is entirely bare of leaves.

15) November 2019 (Geograph-6312657-Fabian-Musto)

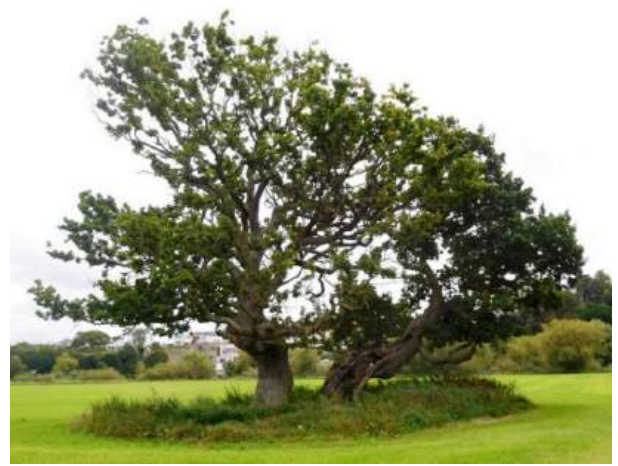
16) Sept 2020 (Photo from TROBI – © Mr S. Young)

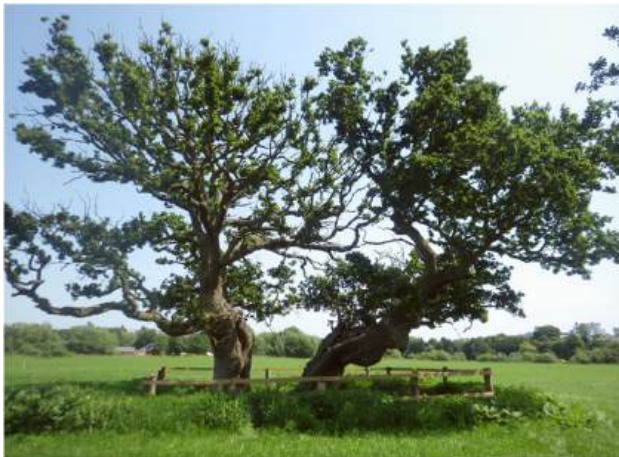
17) July 2021 (Photo JPR)

In practice a fence was put in place but set about 4 metres away from the two stems, which rather less than the general crown-spread of the tree and much less than its likely root spread. (See photo 17). However, it did and continues to limit trampling by livestock in the immediate vicinity of the two stems.

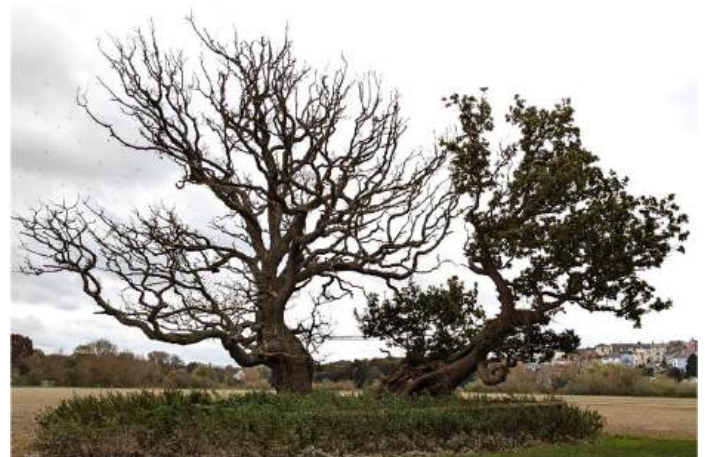
(Photo 2 – October 2024 (Photo JPR)

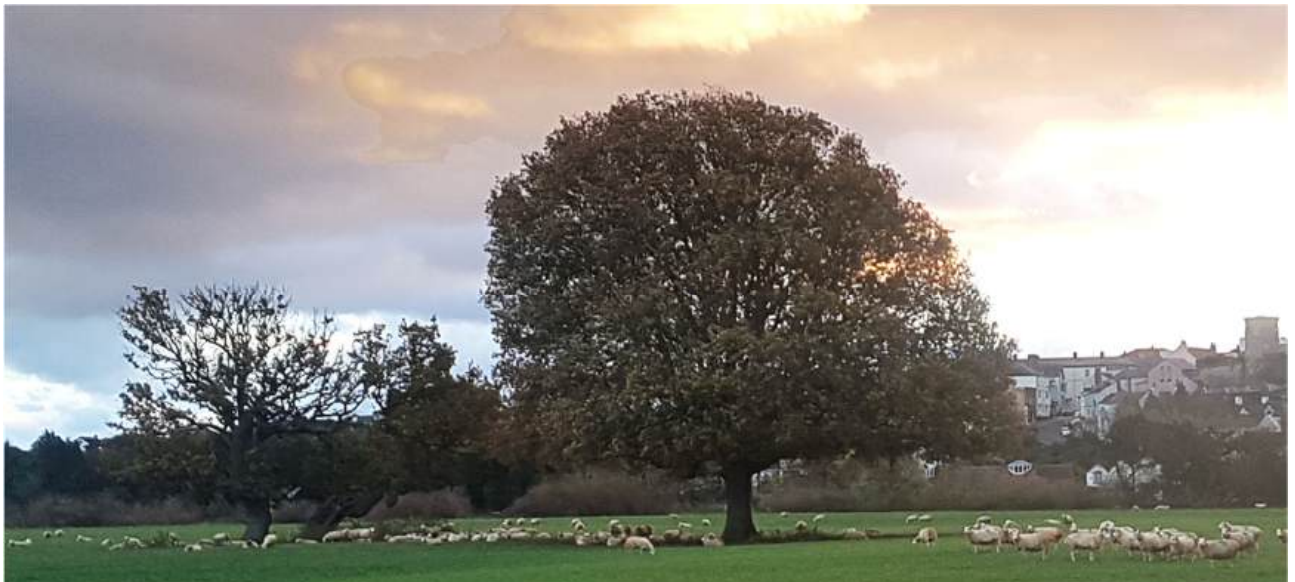
(18)

Most trees in Britain have root systems of which 90% are within the upper 60cm of soil and, as free gaseous exchange is necessary for healthy roots, the majority of the fine, feeding roots are to be found in the more aerated strata, close to the soil surface. This means that they are potentially vulnerable to damage from soil compaction, which will inhibit gaseous exchange, as well as to physical disruption caused by cultivation. I don't have any detailed records of historical land use here but it seems probable that it has predominantly been used as pasture. The pencil sketch of 1866 (photo 7) shows the tree with sheep grazing nearby, while there are several photographs that indicate livestock with free access under and around the trees, would no doubt have given rise to some ground compaction

Photo JPR – 02 Nov, 2020

In recognition that trampling by livestock could be having a deleterious effect, a recommendation was made in 2020 that an area should be fenced off to create a buffer zone around the tree, effectively a Root Protection Area (RPA), it being suggested that this should be set about 21m from the tree⁶. Based on the guidance that a veteran tree should have a root protection area of radius 15 times the diameter of its trunk, in this case using the diameter of the larger trunk which was found to be 1.43m. $[1.4 \times 15 = 21]$

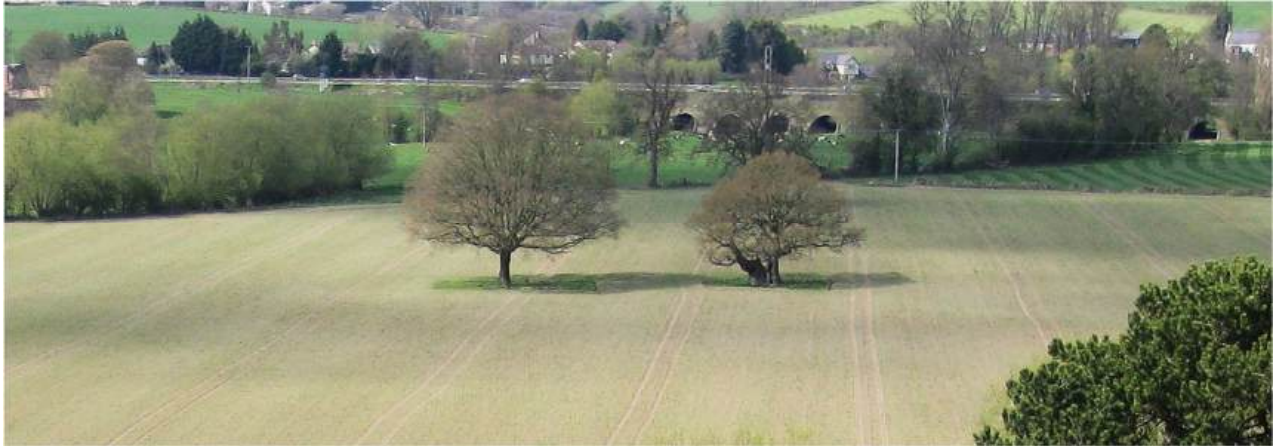
some compaction of the soil within the rooting areas of the trees, areas that will extend *well* beyond the trees' crown-spreads.

(19) The field evidently with a developing crop. Note the 'tramlines' 16 April, 2010 geograph-1809499-by-Pauline-E

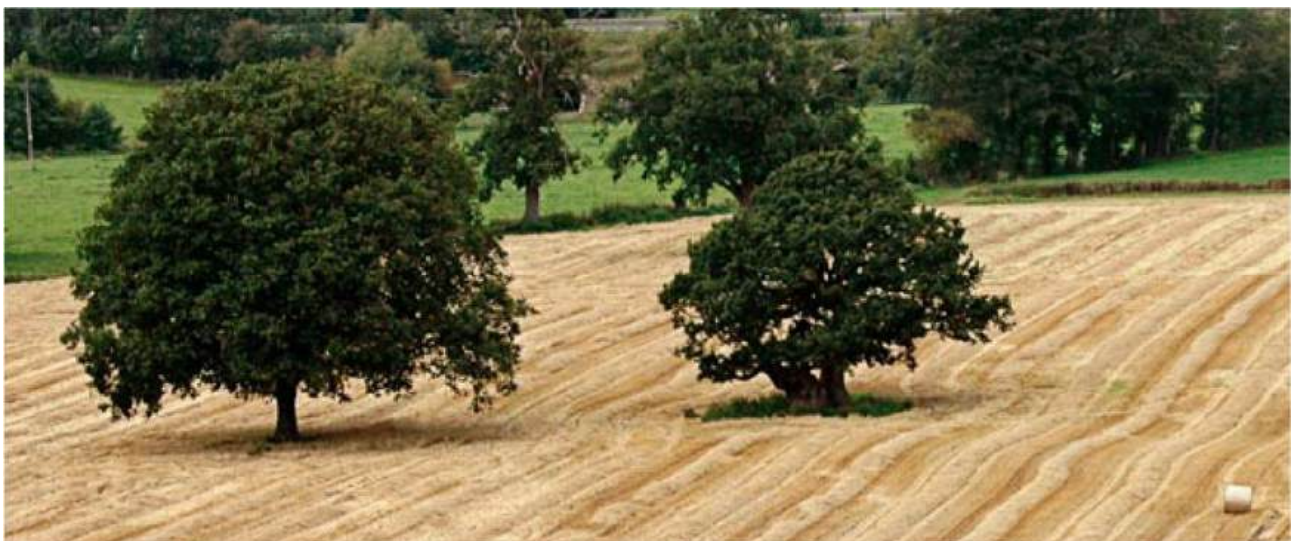
(20) August 2004 Photo © Roger May (cc-by-sa/2.0)

The degree and extent of root disruption will depend on a number of factors; trees may acclimatise to relatively shallow cultivation carried out regularly over an extended period. However ploughing of land that had previously been largely uncultivated over many years could prove to be particularly damaging, especially to an ancient tree with reduced vigour. Photograph 1, at the beginning of this article, appears to show the land immediately around the tree had been recently cultivated. The photograph was taken in 2012, before the progressive decline set in.

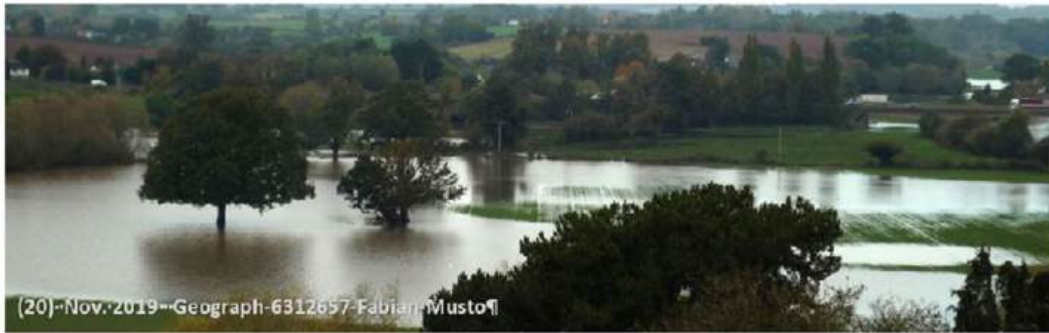
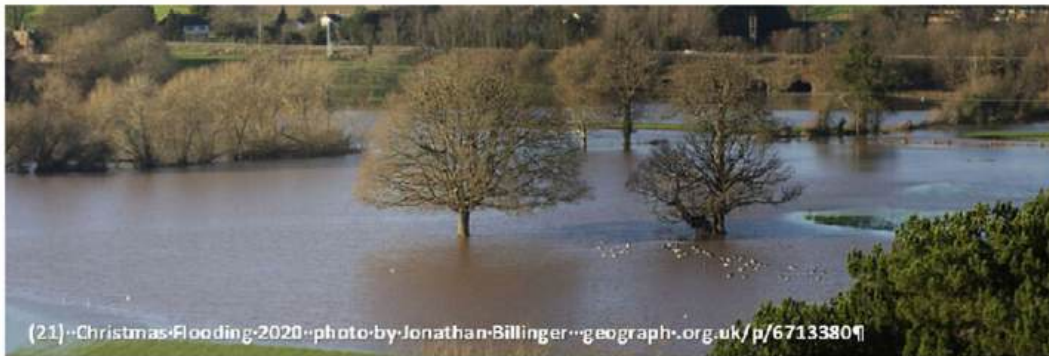
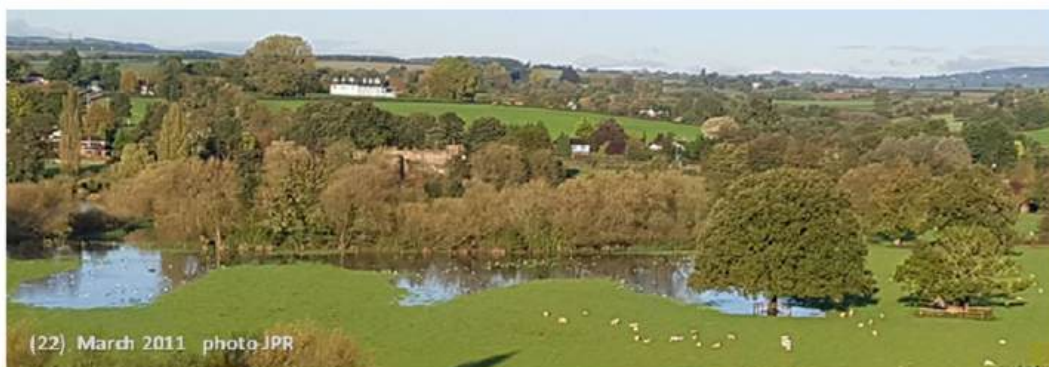
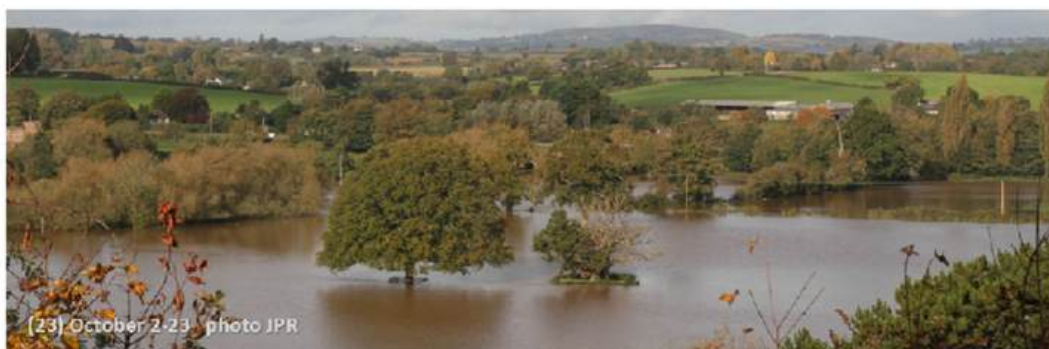
Oak Meadow in Flood:

The tree is growing on a flood meadow and it's by no means unusual to see it under water and there are many photographs that show it surrounded by floodwater, including photo 9, dating from 1914. Othe images are provided overleaf.

While one might reasonably presume that flooding is likely to provide an inhospitable environment for healthy roots, any such presumption must be called into question by the very frequency of these events: this is a tree that has been growing for its entire life on a flood meadow that has been subject to frequent flooding over several hundreds of years, sometimes several times a year, and the tree evidently tolerated and indeed flourished under these conditions. There seems, therefore, to be no reason why flooding alone should have caused its decline over the past few years.

However, while the tree may be acclimatised to being inundated by flood water from the River Wye over many years, the *quality* of that water has undergone a major change over the past ten years or so. The once common white flowers of water crowfoot have disappeared from the river, there have been increasing reports of algal blooms while the numbers of fish and other water creatures have become ever smaller. This catastrophic damage to the river's biodiversity is attributed to pollution from agricultural runoff and sewage discharges raising the levels of phosphates, nitrates and other pollutants in the water.

Further investigation is needed to assess both the current nutrient status of the soil and its mycorrhizal population, but the coincidence of the decline of the tree and the decline in water quality of the river Wye raises the strong possibility that increased nitrogen levels have led to a decrease in the mycorrhizal associations that were instrumental in maintaining the tree's vitality over its long life.
