The Old Oak of Ross

an illustrated story of a tree's survival and decline

Jerry Ross F.Arbor.A

November 2024

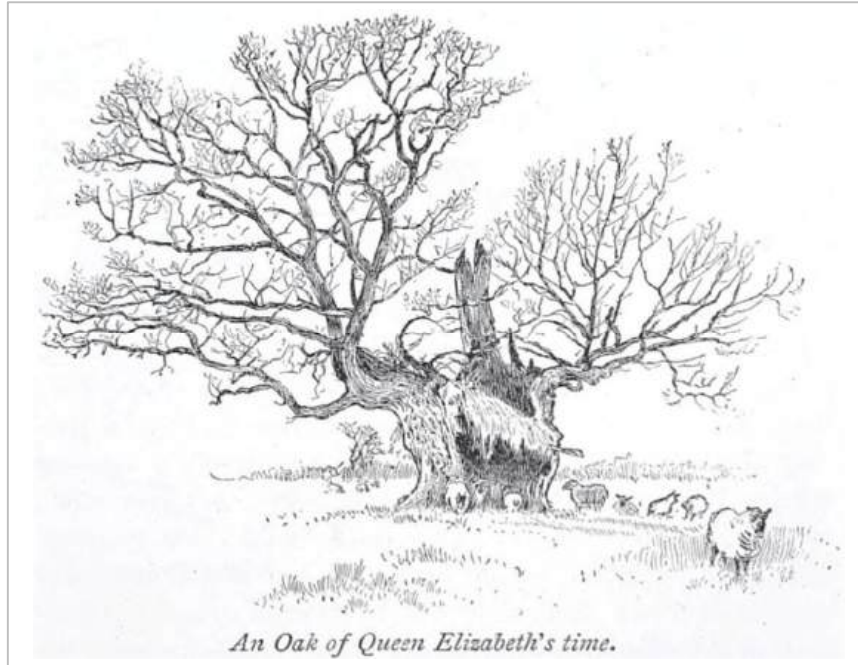
7)

the fire is intense the heat may be sufficient to kill the live wood. In this case it seems as if large areas of wood on the eastern and western sides of the trunk were killed, but sections to the north and south were spared. There are no images that show the western side intact and it appears that it was either burned or else fell away soon after the fire. A pencil sketch of 1866 shows the hollow shell open on the east side with a crude thatch over the central hollow, evidently added to provide shelter for sheep (or, perhaps, for the shepherd).

Photographs from the following decades show the trunk as a hollow hulk, open to the west with the other more or less intact, but becoming more fragmented over time until, by 1929, only the two live sections on the north and west sides remain, leaving only the two live sections on the northern and southern sides.

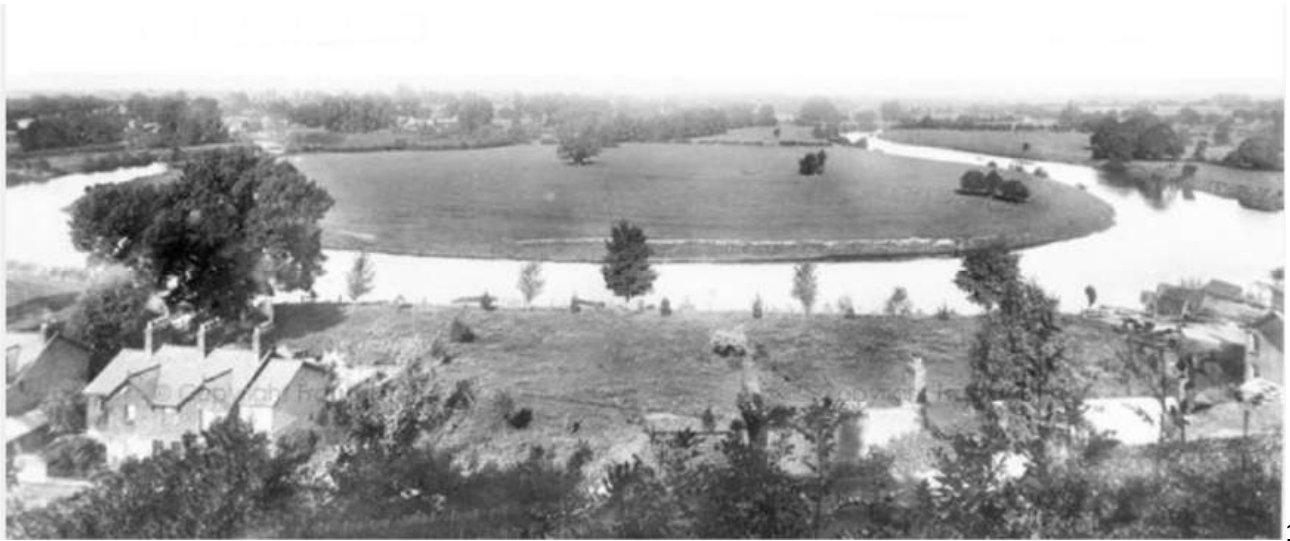
1901

(Note other trees present, but *not* the neighbouring tree)

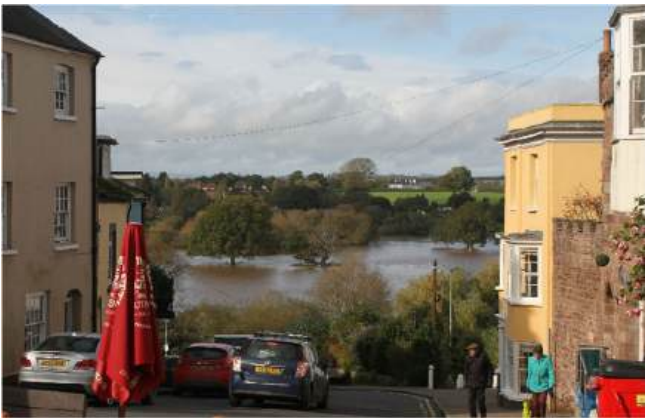
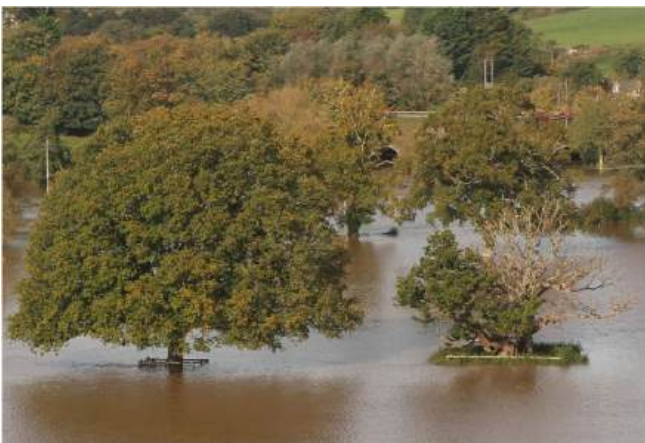
18th October 2024 (JPR)

Sadly, in the few years since then it has shown a very marked deterioration and October 2024 it had declined so far that the more upright, northern section of the tree has lost all its leaves, giving every appearance of having died.

Close inspection showed some live buds remaining and it is possible that these *might* give rise to some scattered new growth next spring. However, it's clear that the tree, or at least this northern part of it, is in serious trouble and that its long life may be drawing to an end.

Images from 2019 to 2014 are provided overleaf and show a marked, progressive deterioration over the period until in October of 2024 the northern (left-hand) section of the tree is entirely bare of leaves.
