Deepdale Bridge

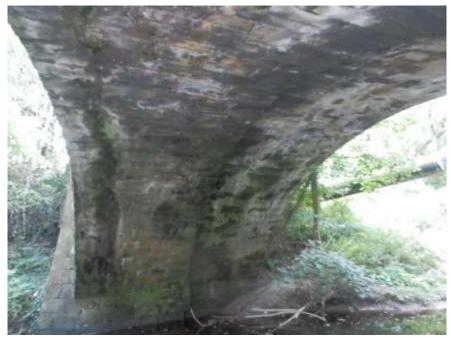
The older, downstream side on the left, newer upstream side on the right.

It is a single segmental arch, triple stepped (three layers of arch stones) on the older, downstream side. The upstream extension was built differently, with a slightly wider arch, one layer of arch stones, and two broad flanking pilasters that support small pedestrian refuges. The bridge was built with squared sandstone with tooled dressings and arched parapet copings.

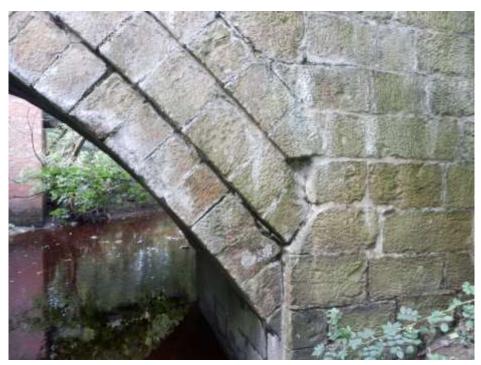
The triple arch on the downstream side.

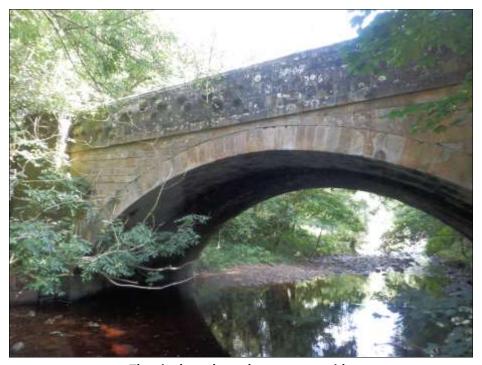
The single arch on the upstream side

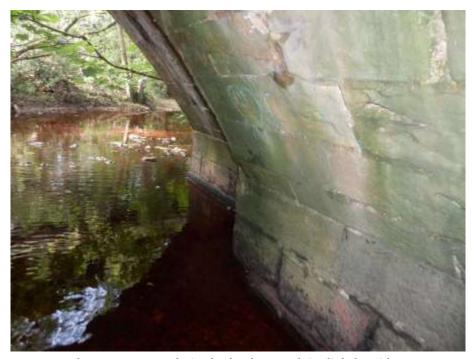
The upstream arch, in the background, is slightly wider.

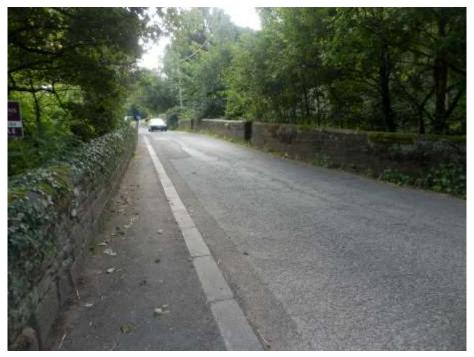
The narrow downstream pavement and the upstream pedestrian refuges.

Nowadays the bridge has a narrow pavement on the downstream side, and the two pedestrian refuges on the upstream side. The bridge is in good condition but is rather inadequate for its current level of traffic, which includes large farm vehicles and cars towing caravans. The setting is adversely affected by the ugly but utilitarian water main pipe which crosses the beck just upstream.
