Plot 4

Plot 3

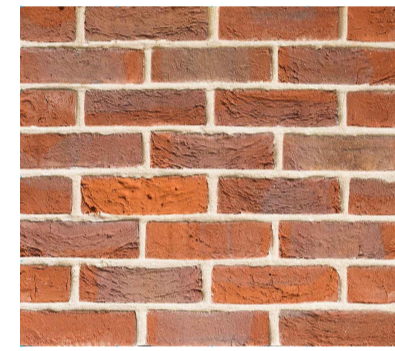
Classic Mixture Facing Brickwork

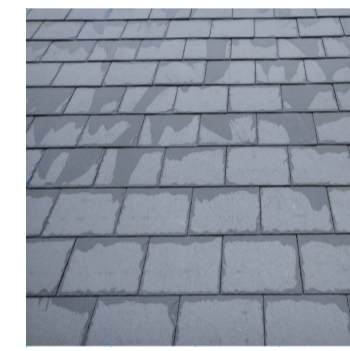
Spanish slate roof tiles

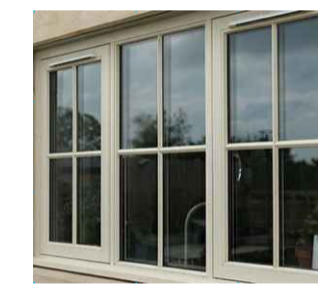
Upvc windows in cream

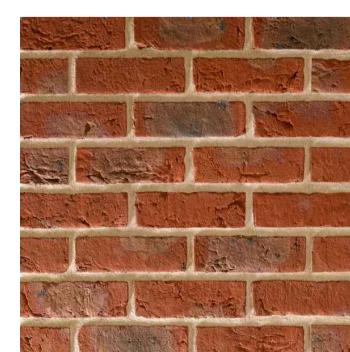
Hamilton Orange Multi Facing Brickwork

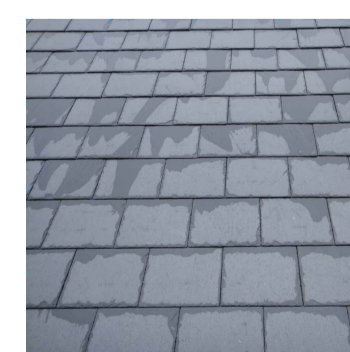
Spanish slate roof tiles

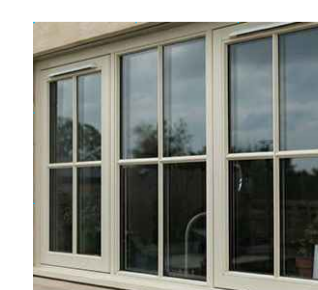
Upvc windows in cream
